SAINT JOHN RIVER BASIN
Limestone, Maine

LIMESTONE DAM ME 00492

PHASE I INSPECTION REPORT NATIONAL DAM INSPECTION PROGRAM

SEPTEMBER 1981

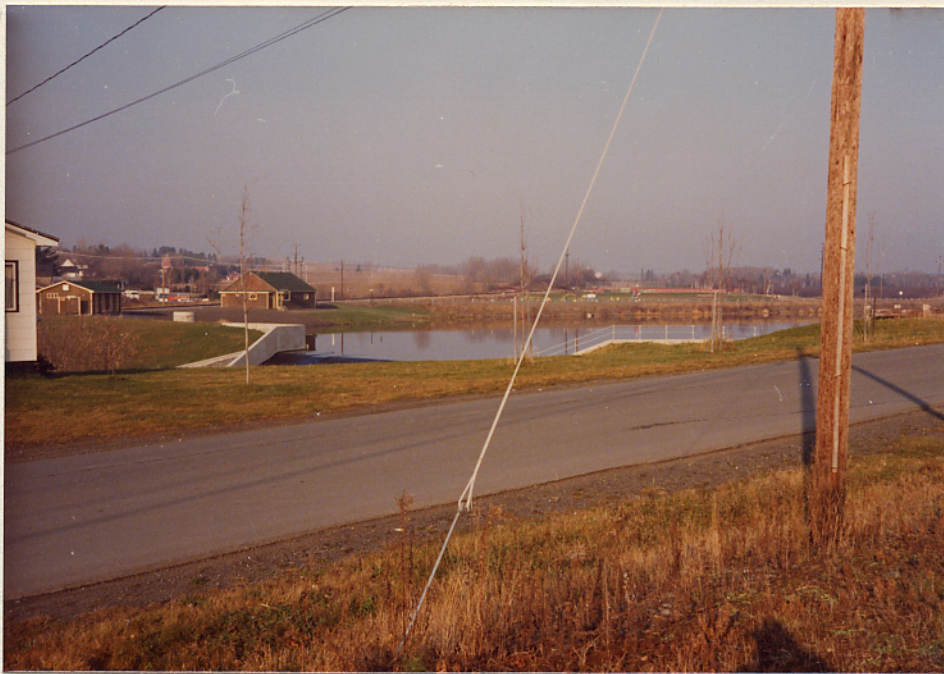
PHOTO #1

VIEW FROM LEFT
BANK ACROSS OLD
HIGHWAY 165

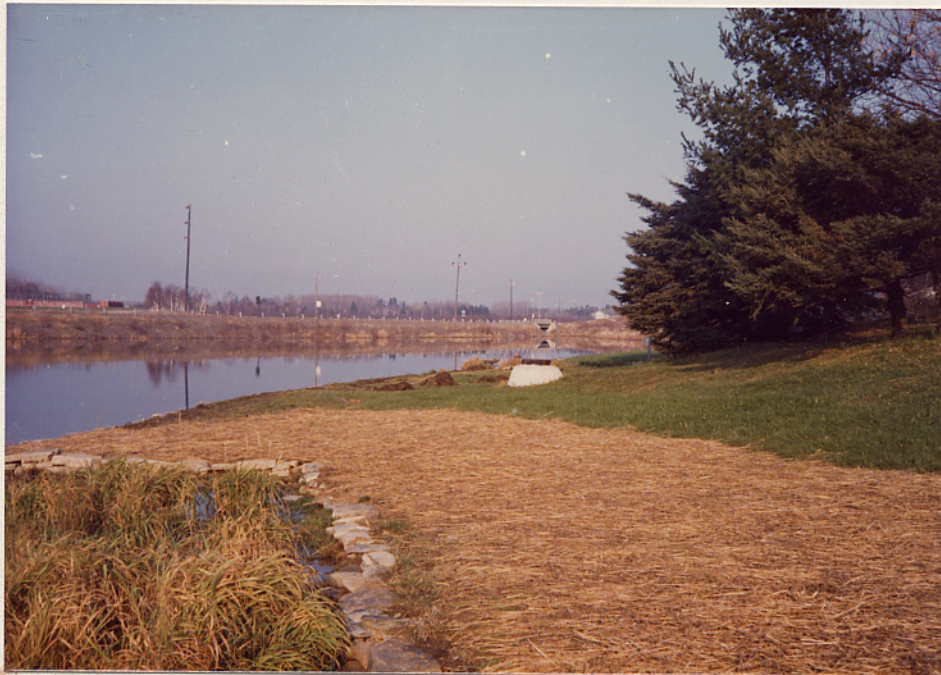
PHOTO # 2

VIEW FROM LEFT BANK
ACROSS OLD HIGHWAY
165

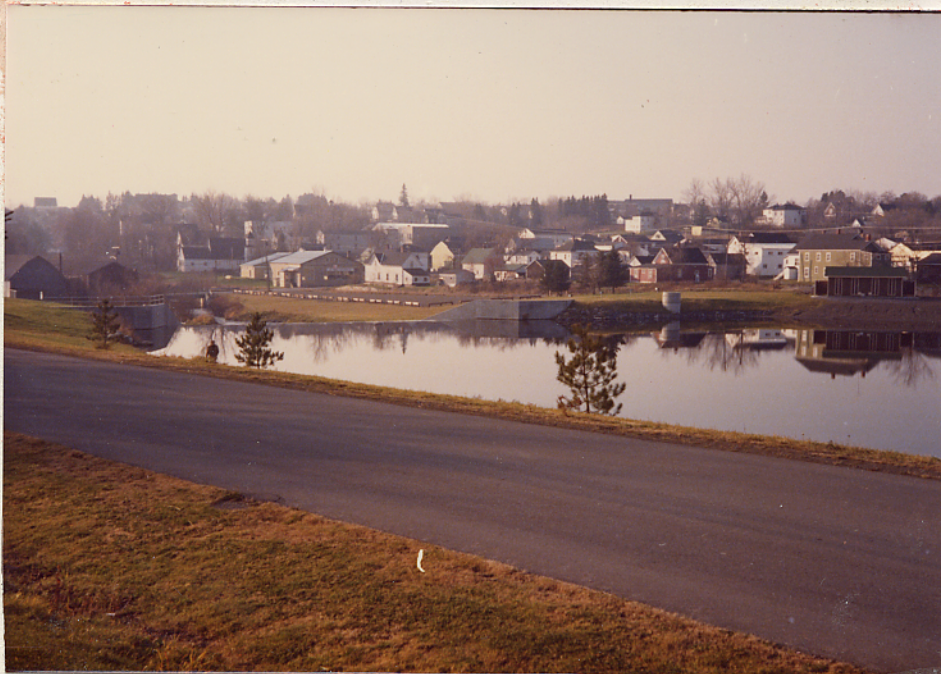
PHOTO # 3

- d. Reservoir Area - No areas of potential or actual shoreline movement were observed (Photo 3).
- e. Downstream Channel - Approximately 200 yards downstream, Limestone Stream flows under Highway 229. The opening in the bridge is approximately 7' x 29'.

UPSTREAM VIEW OF RE-
SERVOIR WITH NEW
HIGHWAY 165

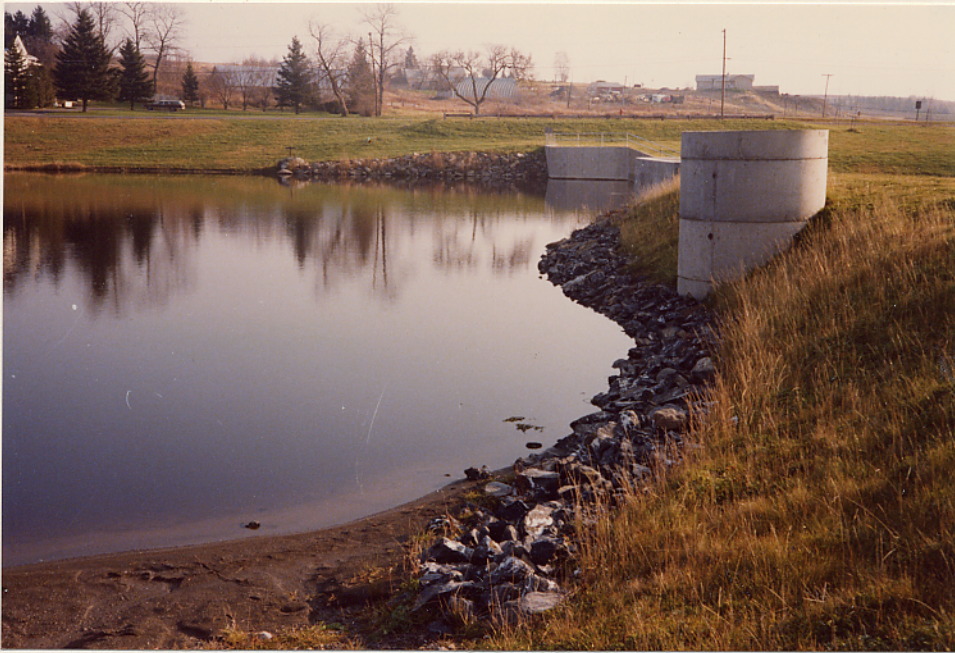
PHOTO # 4

- (2) Upstream slopes - The upstream slope riprap appeared in good condition. The slopes above the normal pool El. 526.5 have a well developed tight grass cover (Photo 4). There was no evidence of sloughing or erosion on the slopes.

RIGHT ABUTMENT WITH
ROCKFILL DAM AND
VALVE SHAFT

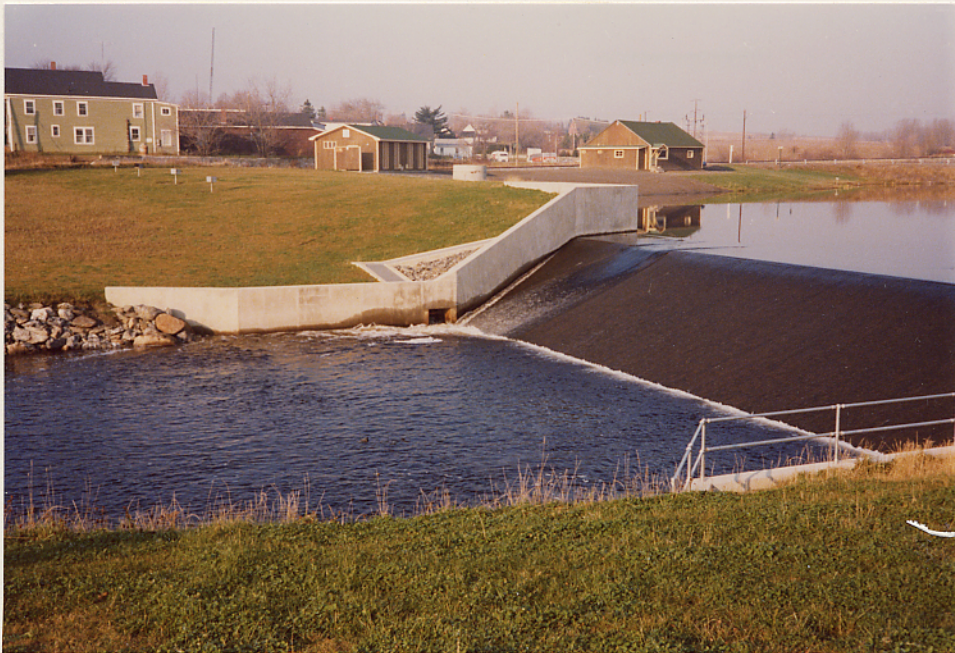
PHOTO # 5

- (3) Downstream slopes - The downstream slope rip-rap appeared in good condition. The slopes have well developed, tight grass covers. No significant gully action was observed on the slopes (Photos 5 and 6). No slides or sags were observed.

- c. Appurtenant Structures
 - (1) Spillway - The broad crested weir spillway and chute were in good condition (Photo 5). The adjacent reinforced concrete training walls were also in good shape with no visible deterioration.

SPILLWAY WITH FISH
LADDER AND VALVE
SHAFT

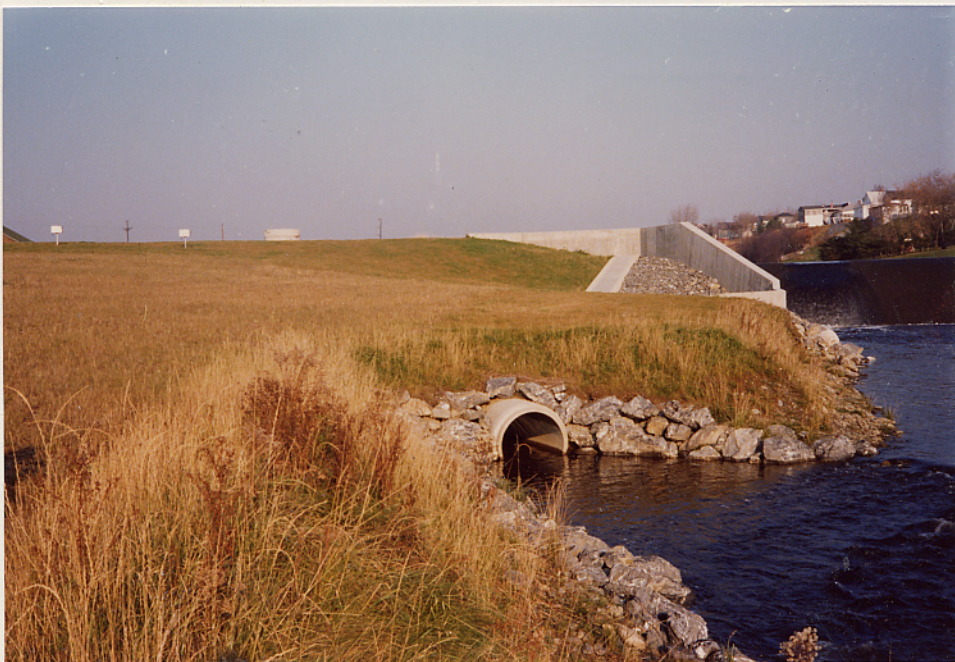
PHOTO # 6

- b. Dam
 - (1) Crest - The embankment crest was true to line with no apparent dips, sags, cracks or other evidence of distress (Photo 6). The as-built camber was observed and appears unchanged. The crest is grass covered with no pavement.

OUTLET PIPE (36")
FISH LADDER WITH RE-
TAINING WALL AND
SPILLWAY

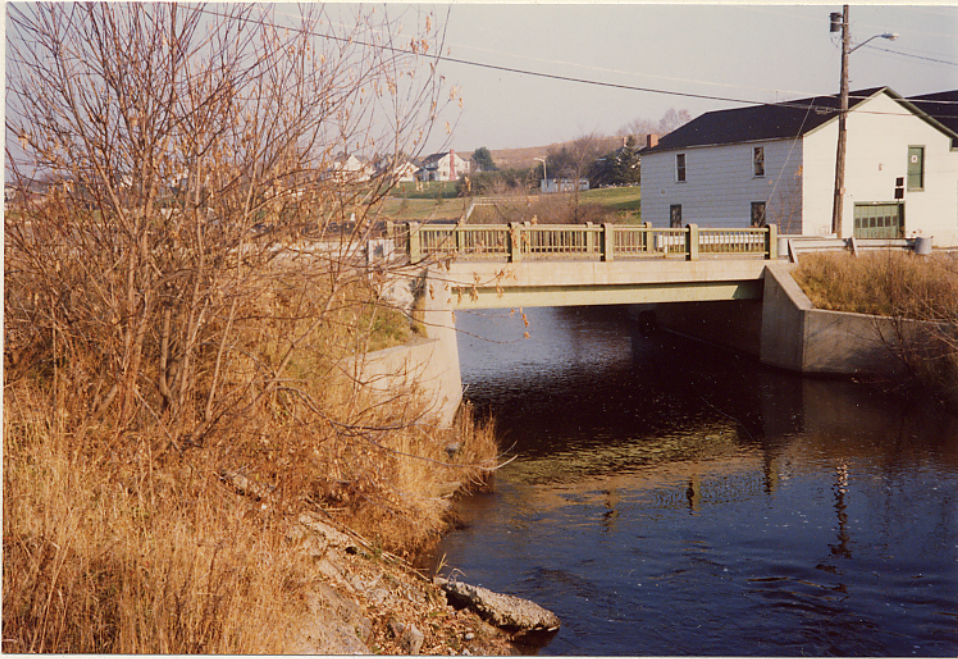
PHOTO #7

VIEW UPSTREAM FROM
BELOW HIGHWAY 229
BRIDGE
